**Smoky Canyon Mine  
Non-Time-Critical Removal Action (NTCRA) – 2015 Activities  
Pole Canyon Overburden Disposal Area**

**Weekly Construction Report**

Prepared by: Formation Environmental (on behalf of the J.R. Simplot Company)

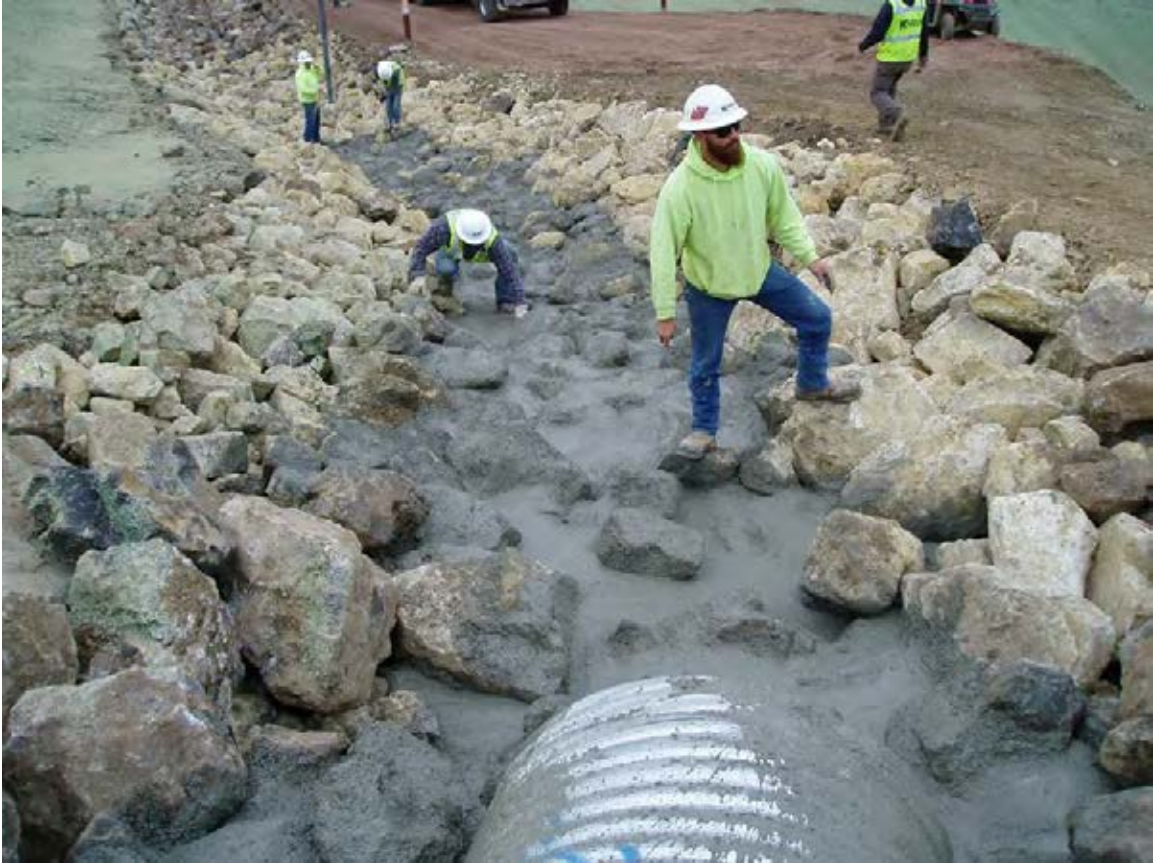
- West Side Run Off Control Ditch
  - Riprap at 42-inch outfall for a distance of approximately 110 feet downstream was grouted in-place (Photograph 9a and 9b).

Photograph 9a: Looking west as riprap at 42-inch dia. culvert outlet is being grouted in-place.

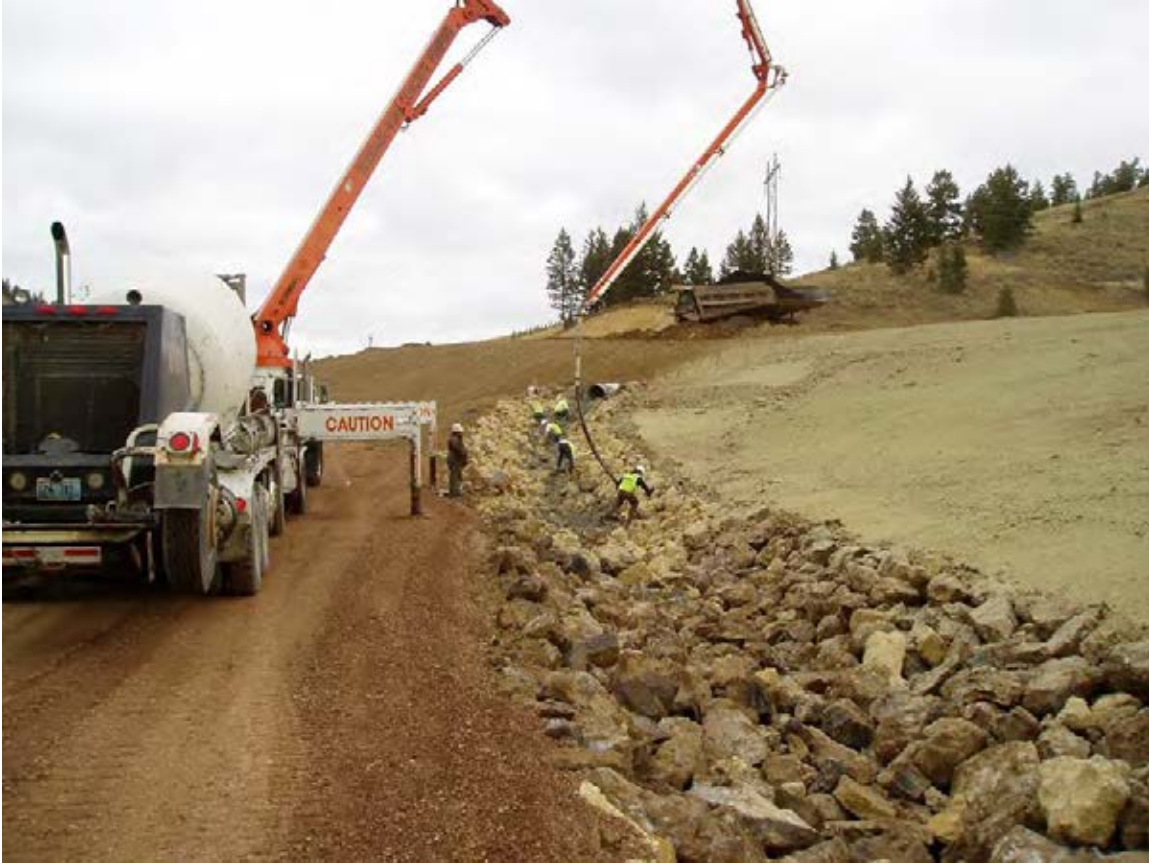
Photograph 9b: Looking north as riprap lined West Side Runoff Control Ditch immediately downstream of 42-inch dia. CMP culvert is being grouted in-place with use of pump truck and tremie tube.

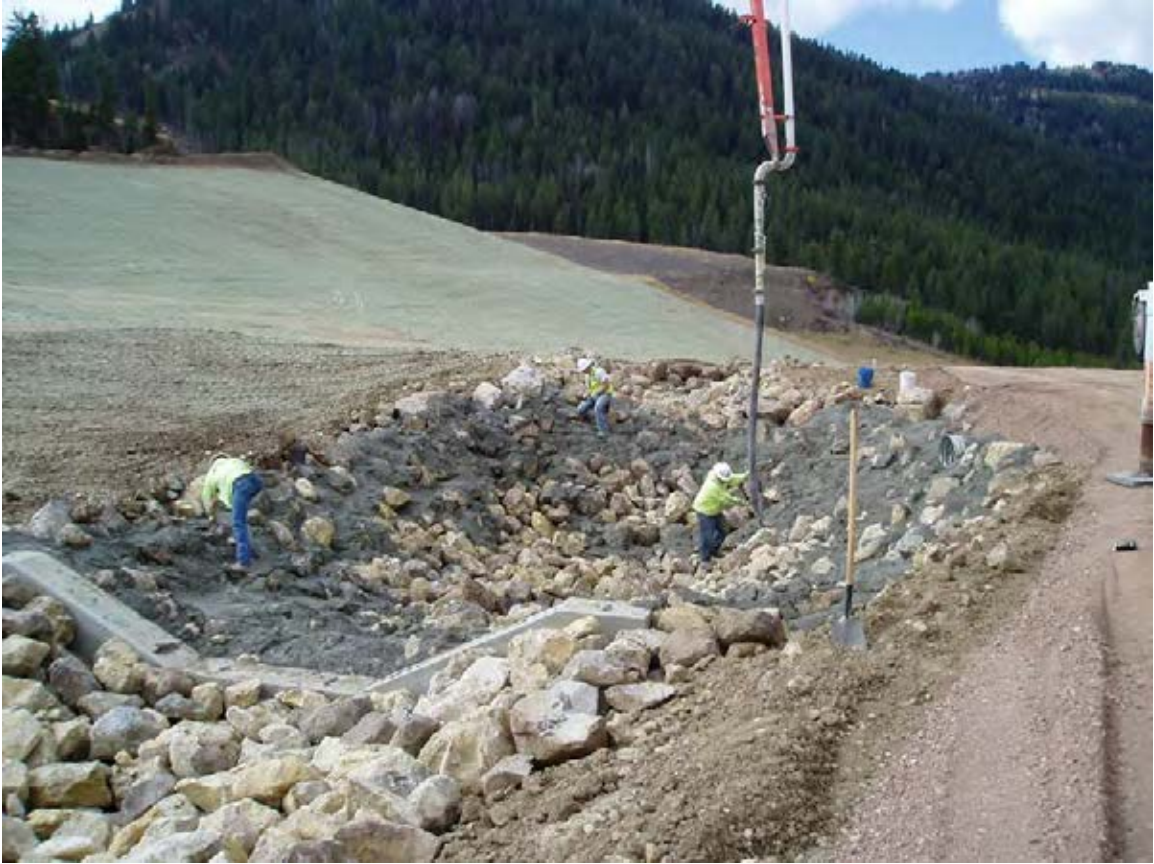
- West EDS completed with riprap grouted in-place (Photograph 10).
  - 48-inch CMP culvert at access road crossing. Culvert inlet grouted. Outlet to be grouted and additional cover needs to be placed over culvert.

Photograph 10: Looking west as riprap lined West Side EDS is being grouted in-place with use of pump truck and tremie tube.

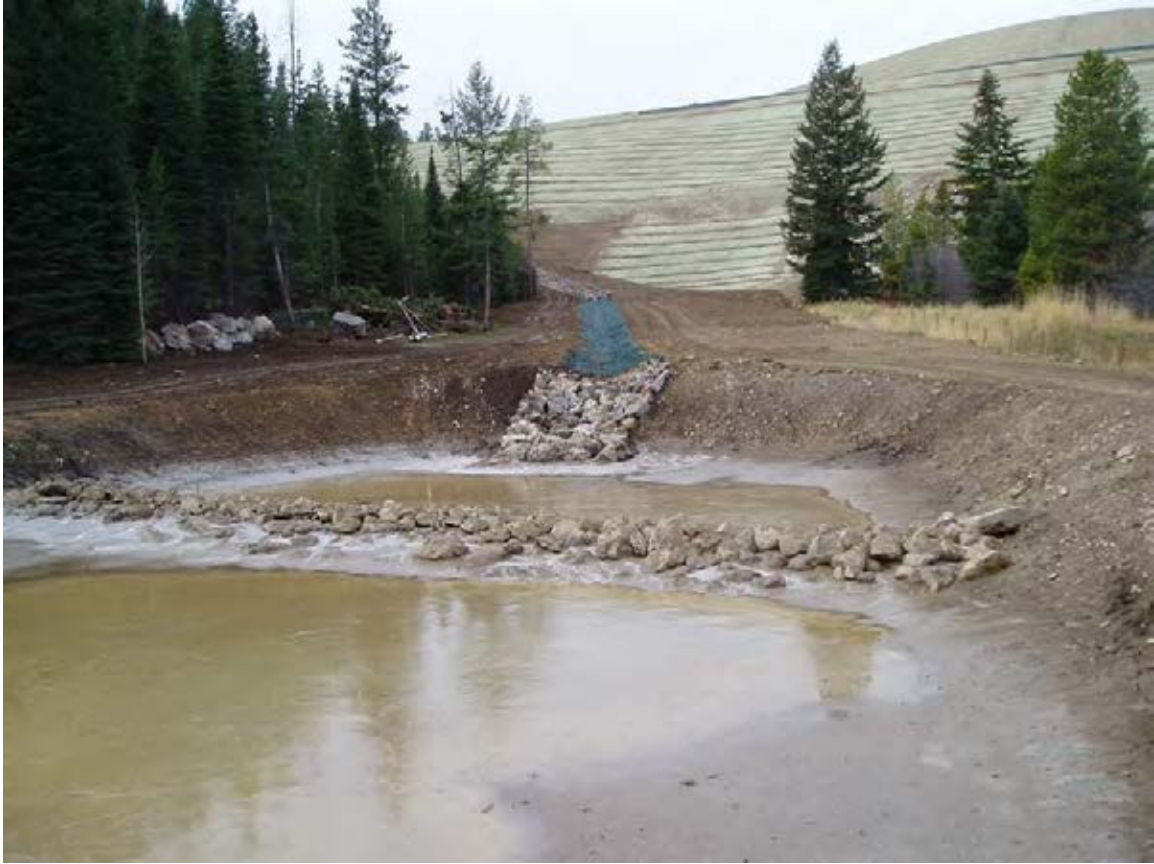
- Initiate V-ditch chute section form bottom up towards saddle Infiltration Basin.
- East Sedimentation Basin
  - No activity; rough spillway requires completion; removal of sediment from basin needed.

Photograph 4: Looking west from East Sedimentation Basin east embankment at spillway towards basin inlet of Southeast Runoff Control Ditch. Note sediment in basin on both sides of flow through rock sediment catchment berm.

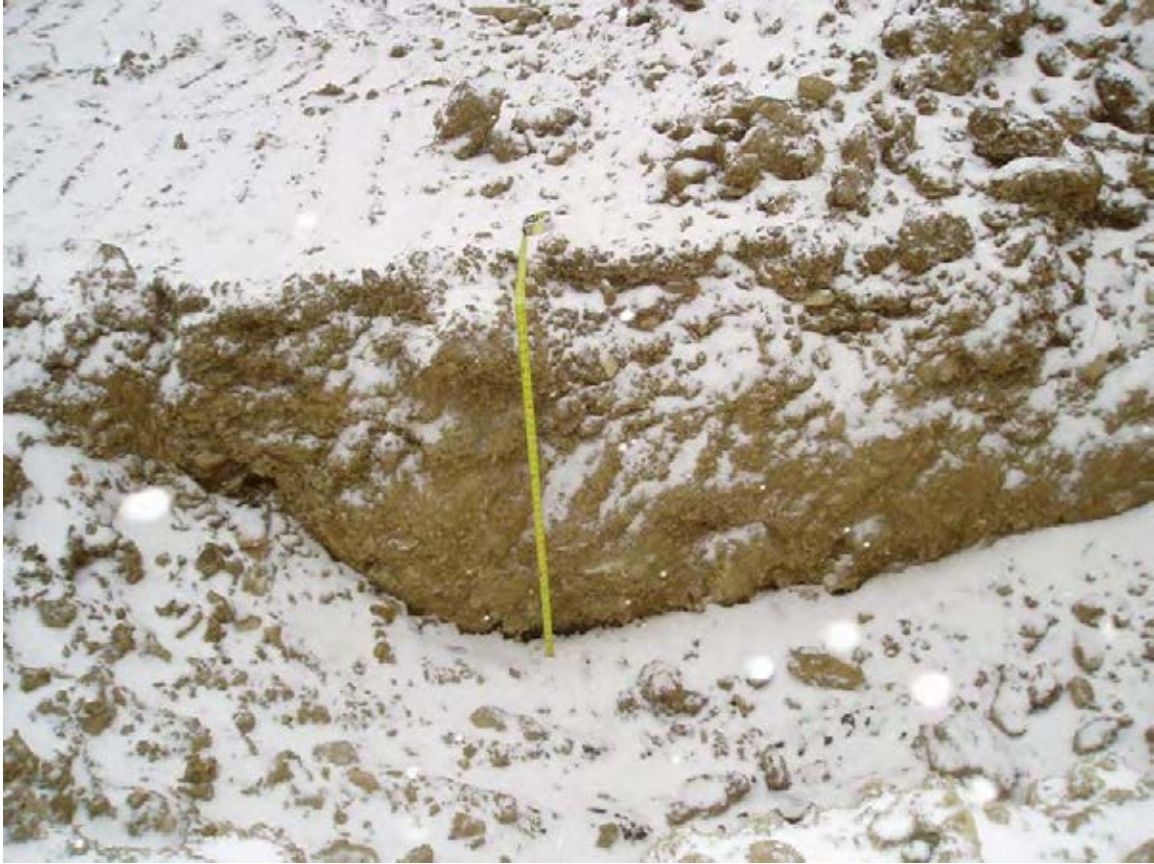
Photograph 3: Looking at one of the 20 test pits excavated to determine the existing cover thickness over the 6 acre area between the mine haul road and the new blast complex. This test pit indicates approximately 3.5 feet of Dinwoody material is present.

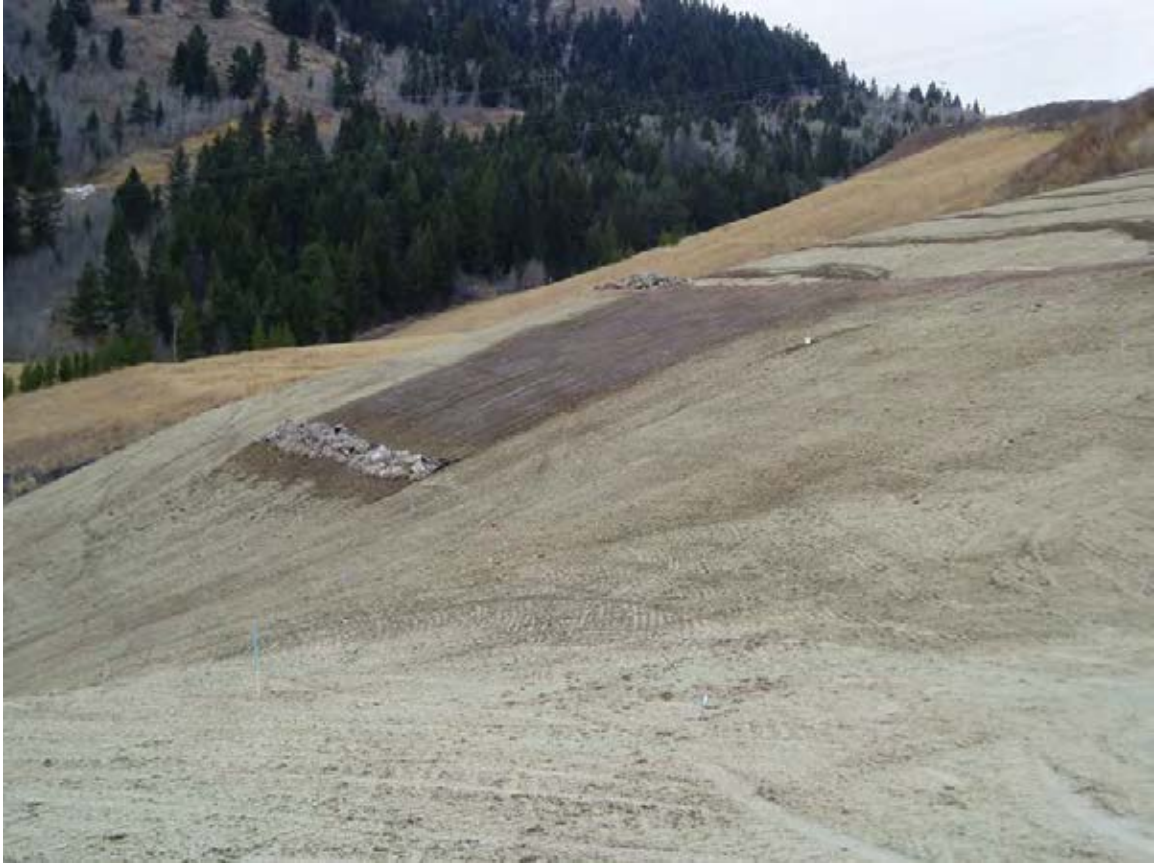
Photograph 4: Looking northwest at the West Side ODA west slope and the initial placement of boulders for the rock buttress required on a portion of the slope that is less than 2.5(h):1(v). Note the white object sticking up above the ground surface which is borehole permeameter test setup for Cover Unit 12.

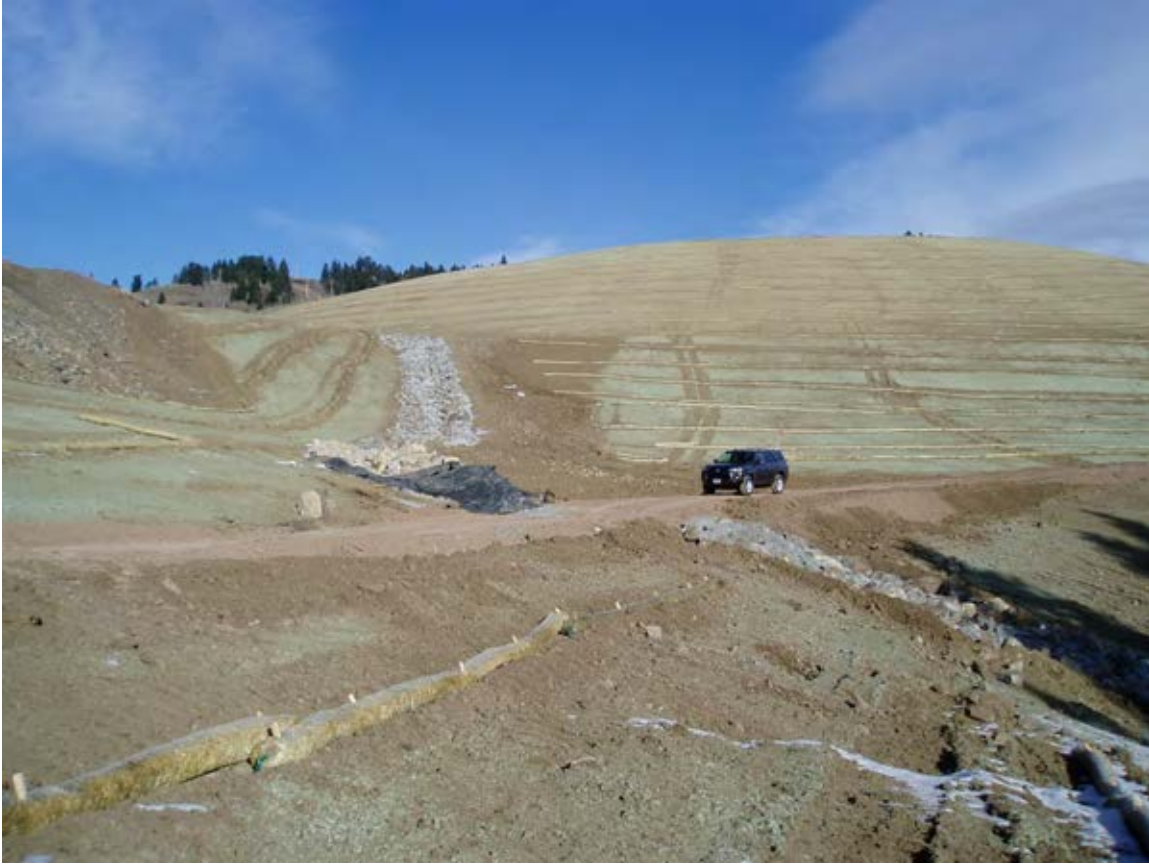
Photograph 1a: Looking north from South Central Sedimentation Basin at the Upper East Side Chute, Concrete Swale at Access Road Crossing and Cute Outfall into sedimentation basin. Geofabric placed underneath all riprap and rip rap upstream and downstream of access road crossing has been grouted.

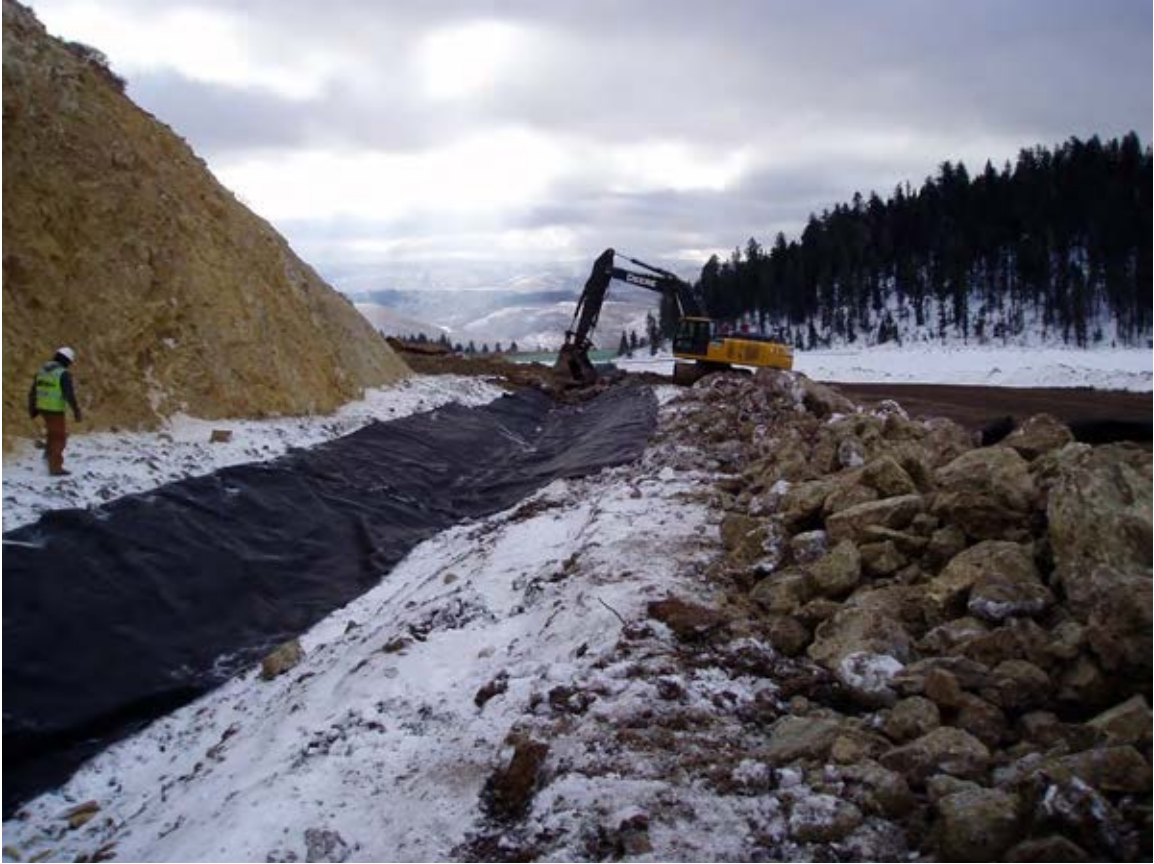
Photograph 5b: Looking south along Panel A Runoff Control Ditch immediately upstream of 42-inch dia. culvert intake structure as excavator places riprap on geofabric for lining armament.

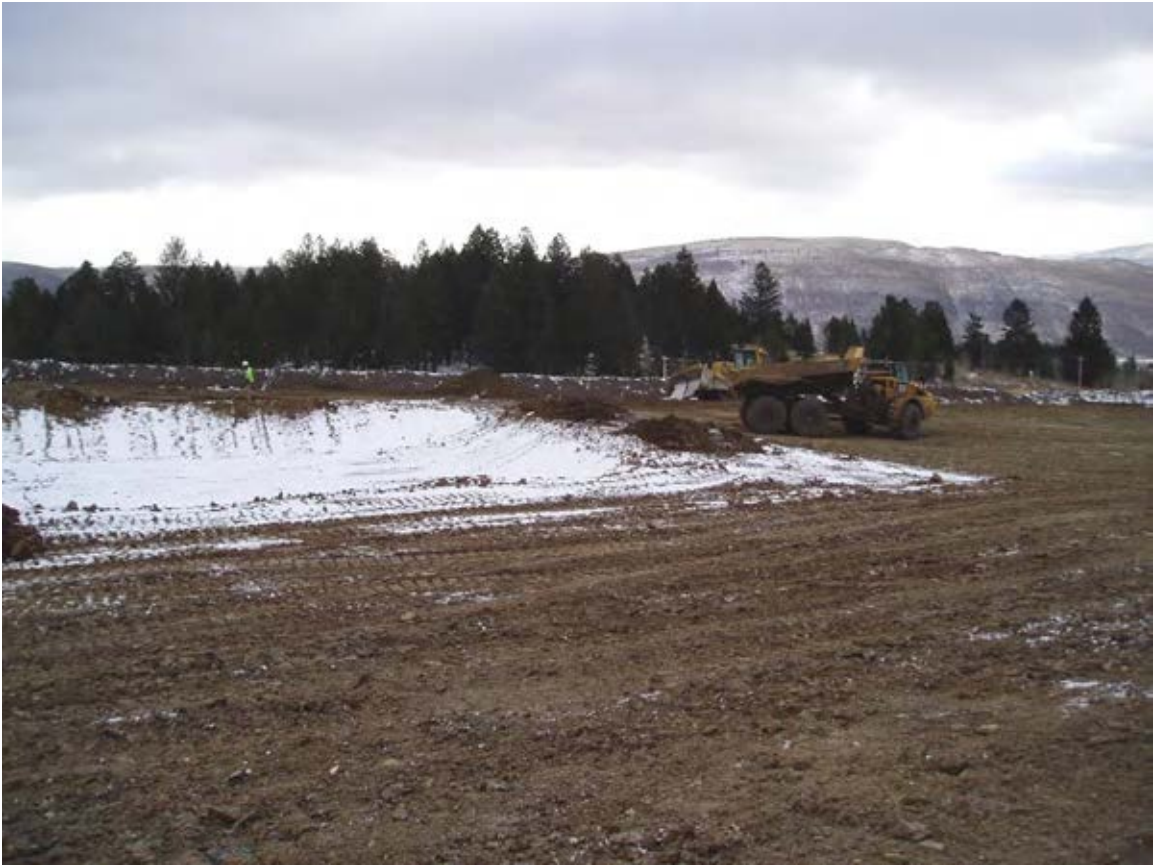
Photograph 6: Looking east at rough grading of West-Side South Sedimentation Basin and surrounding area. Ground surface in photograph is the upper chert layer cover surface being graded and prepared for Final Dinwoody cover material. Small piles of excavation spoil on top of embankments were created by dozer excavating test pit/pads for field density QA testing.

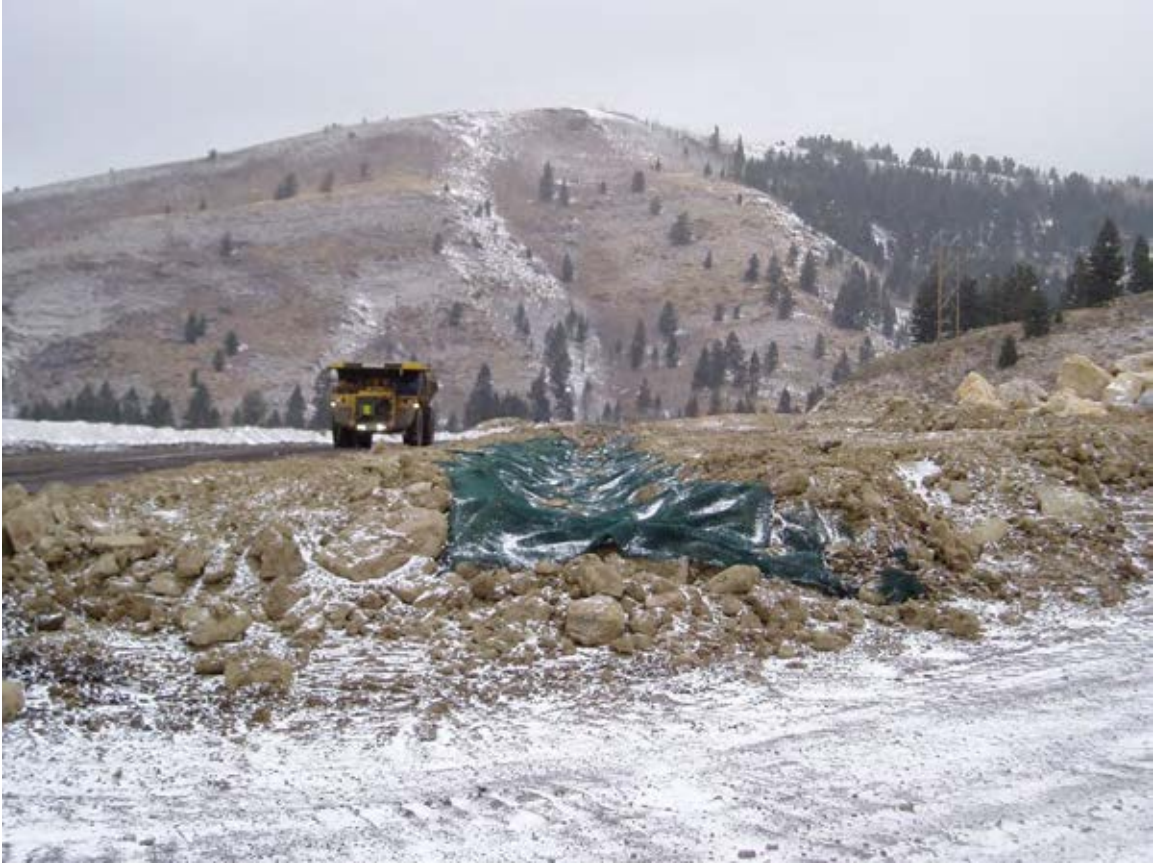
Photograph 1: Looking north (upstream) along East Side Haul Road Ditch from existing access road to New Blast Compound. TRM lining is in place and anchored along both sides of ditch crest.

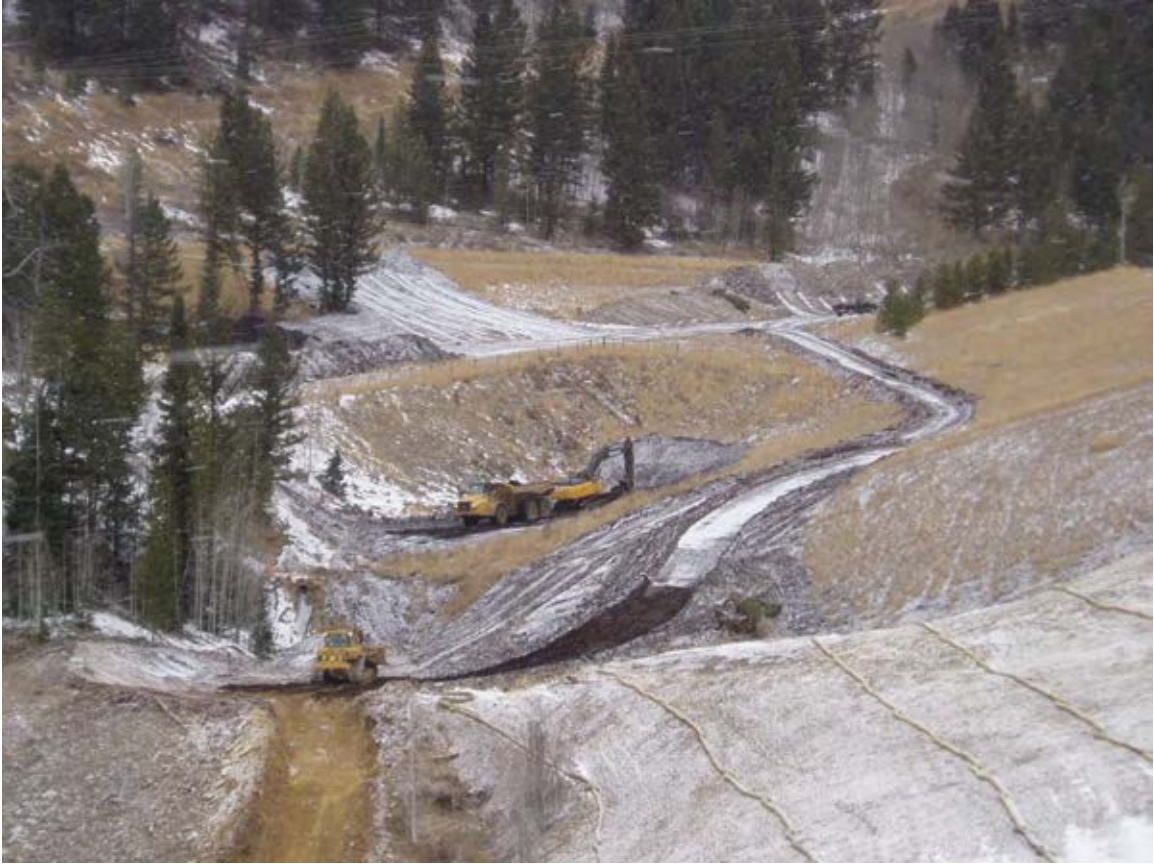
Photograph 2a: Looking northwest towards Northwest Sedimentation Basin as equipment begins excavation to enlarge the basin.

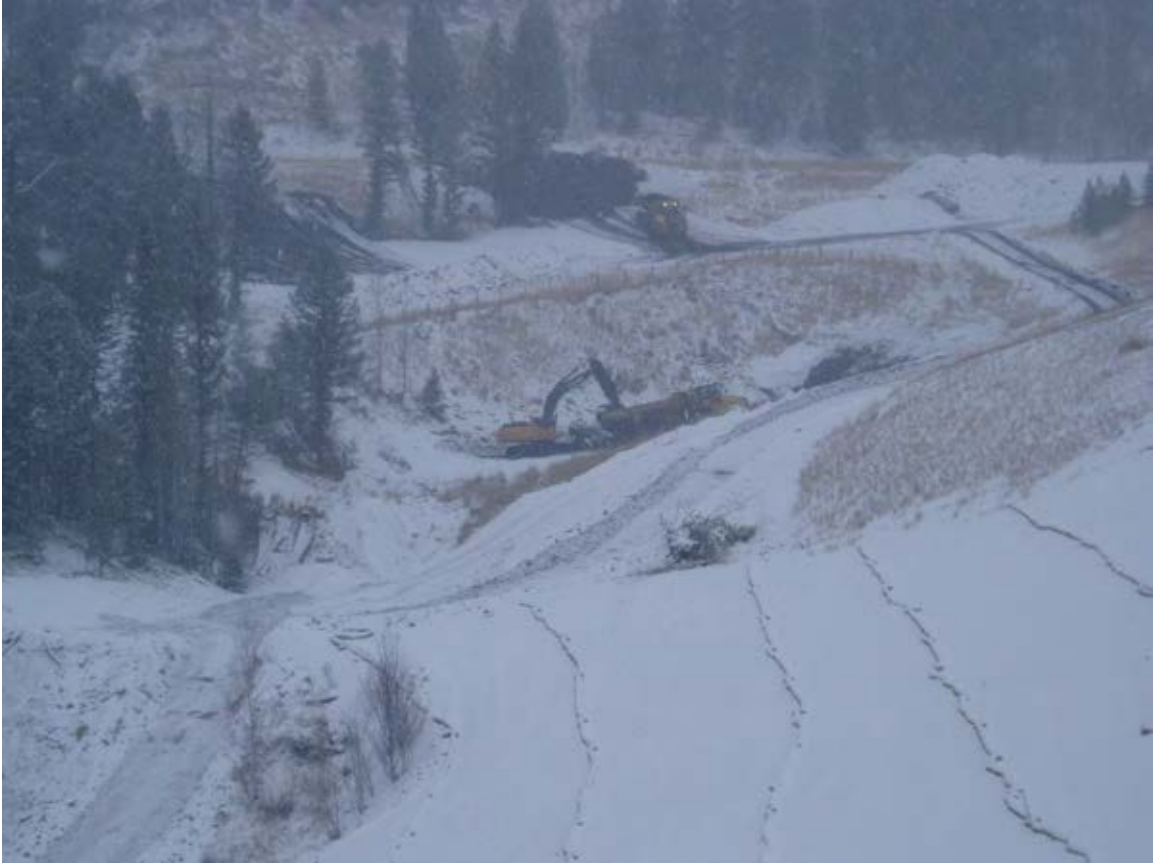
Photograph 2b: Looking northwest towards Northwest Sedimentation Basin as equipment continues excavation to enlarge the basin. Material excavated is being temporarily stockpiled in background of photo.

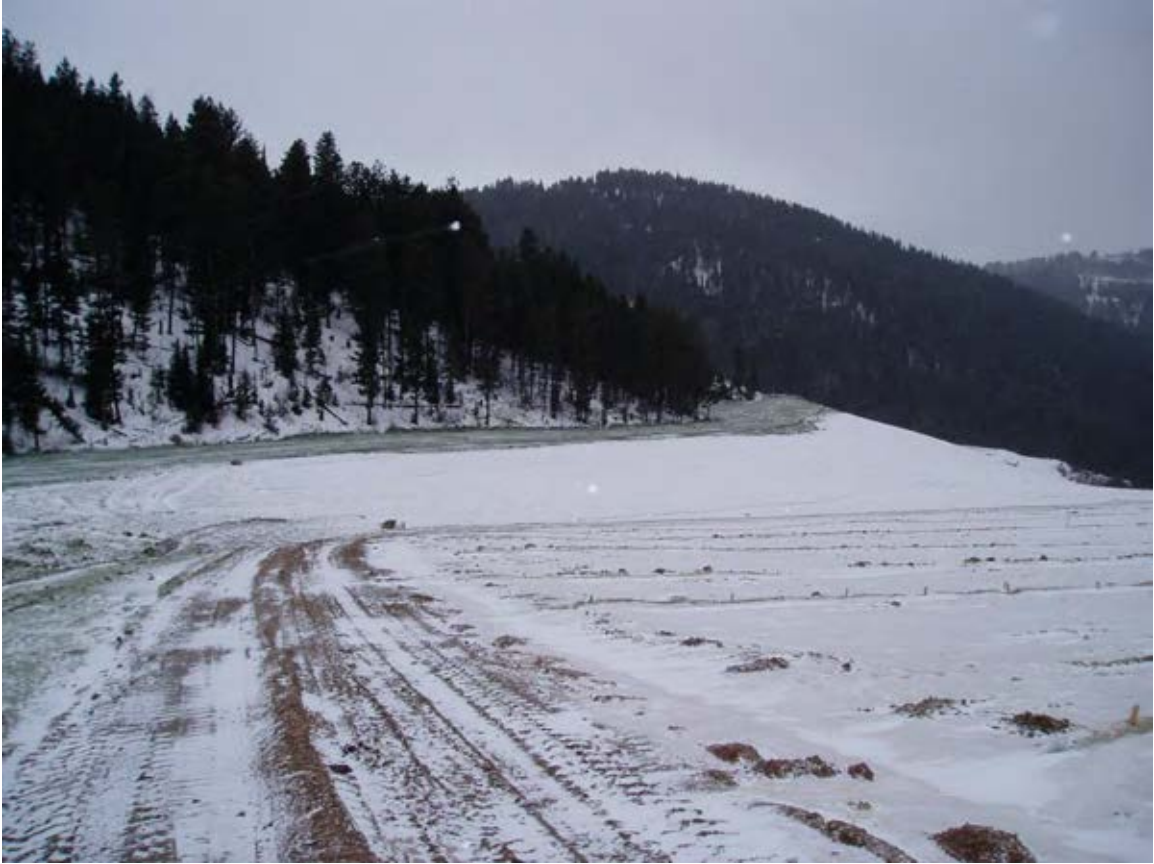
Photograph 3: Looking west at the reclamation of north access road that has been graded to blend road surface into surrounding terrain in panels WS-R2 and WS-R2-M in addition to hydroseeding surrounding area.

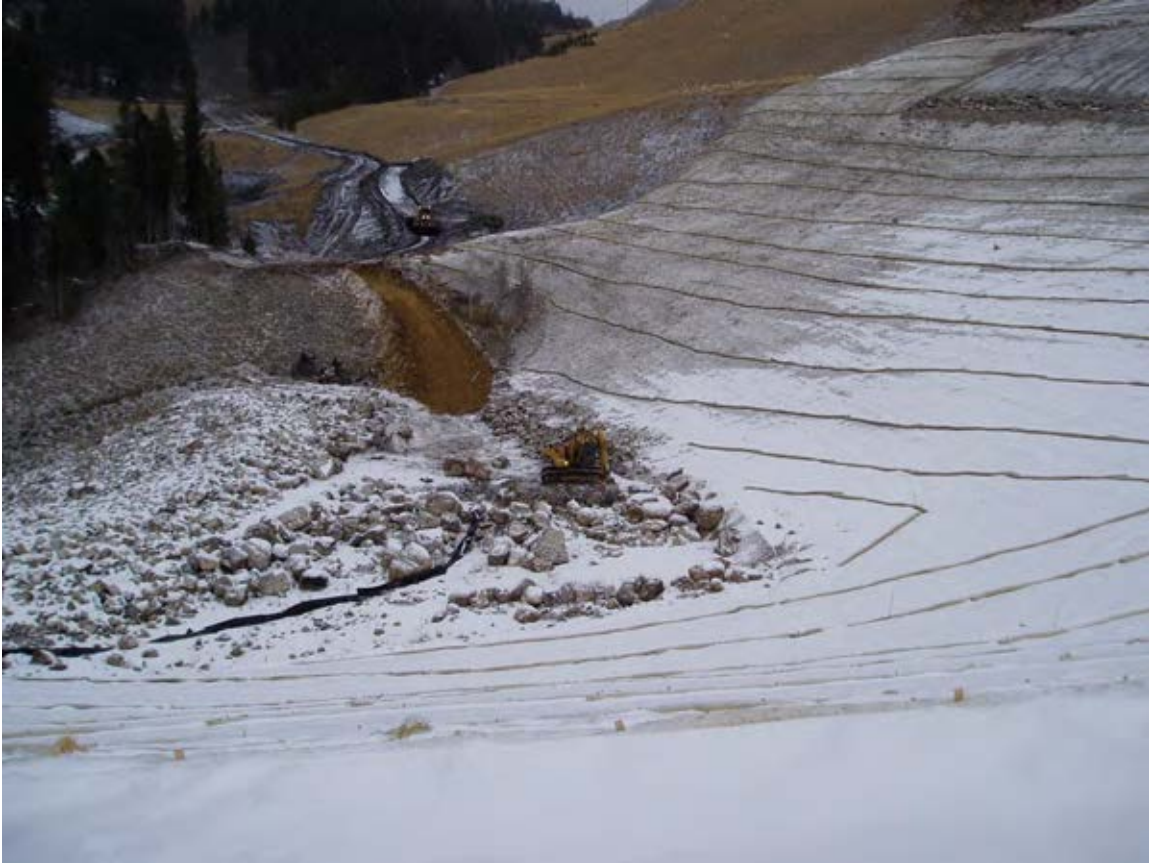
- Construction of top area runoff control berm along east, south and west crest substantially complete.
- West Side ODA Cover Construction
  - Initiate ODA cover extension on lower west toe area above infiltration basin by relocating boulders left over from prior infiltration basin construction (Photograph 4).

Photograph 4: Looking north as excavator, in foreground, sorts through boulders at the west toe of ODA in preparation of final cover in this area and at a dozer, in background, preparing access road for construction of Northwest Sedimentation Basin.

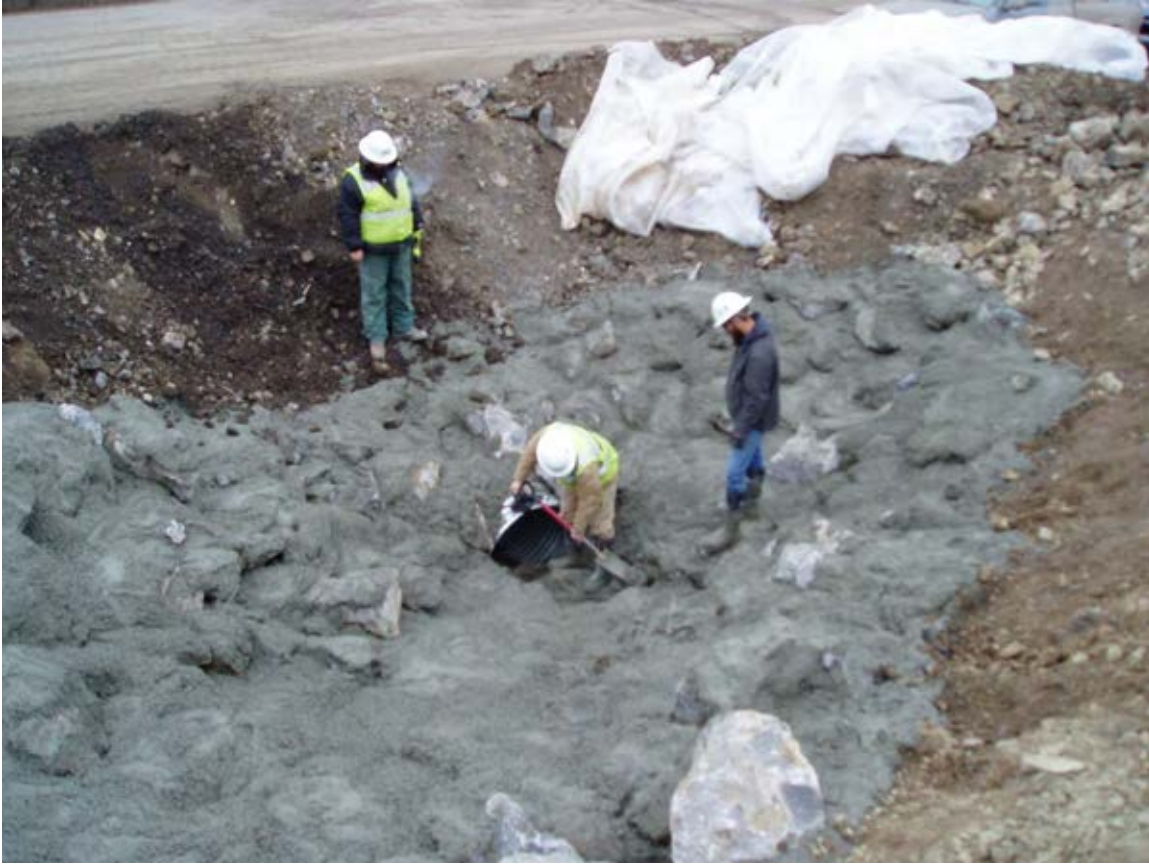
Photograph 5: Looking at the intake for the 36-inch dia. (South) Culvert immediately after placement of grout for riprap.

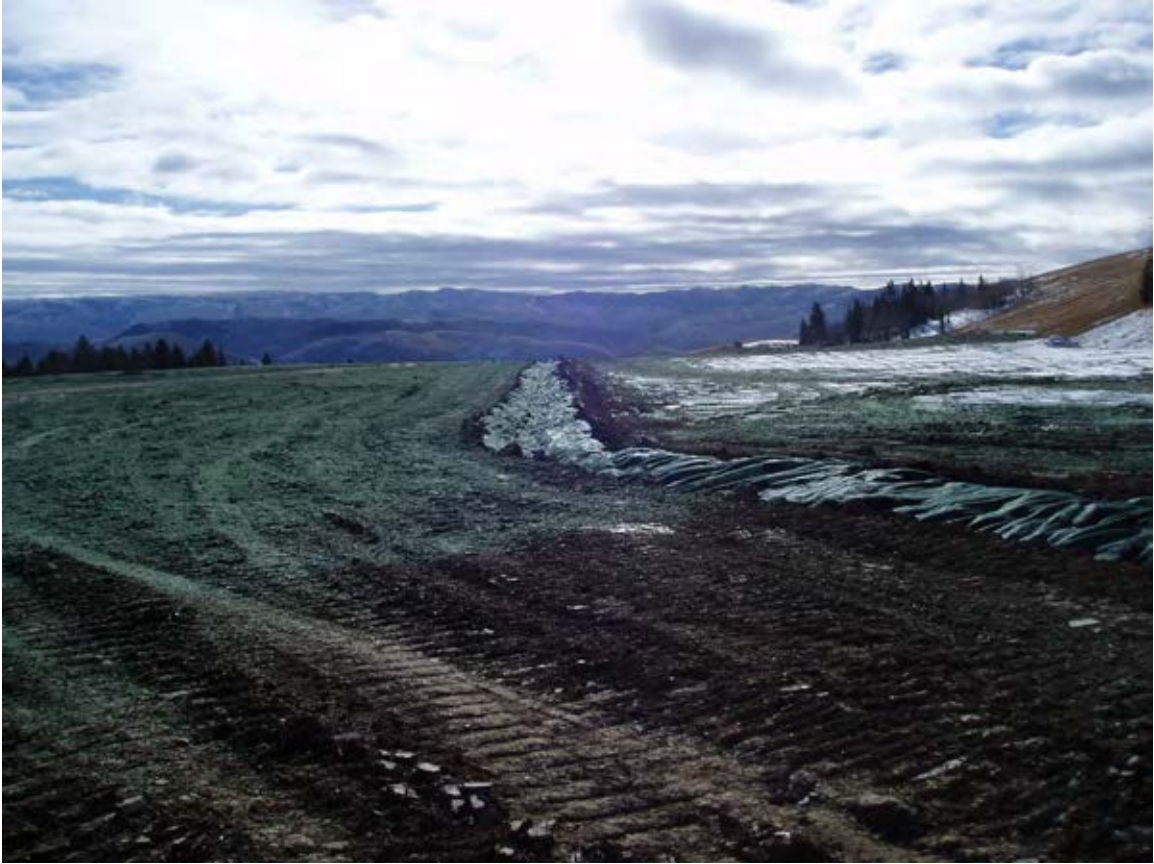
Photograph 6a: Looking south along the West-Side South Runoff Control Ditch to South upstream of West-Side South Sedimentation Basin. TRM has been placed and anchored on ditch crests and surrounding area hydroseeded.

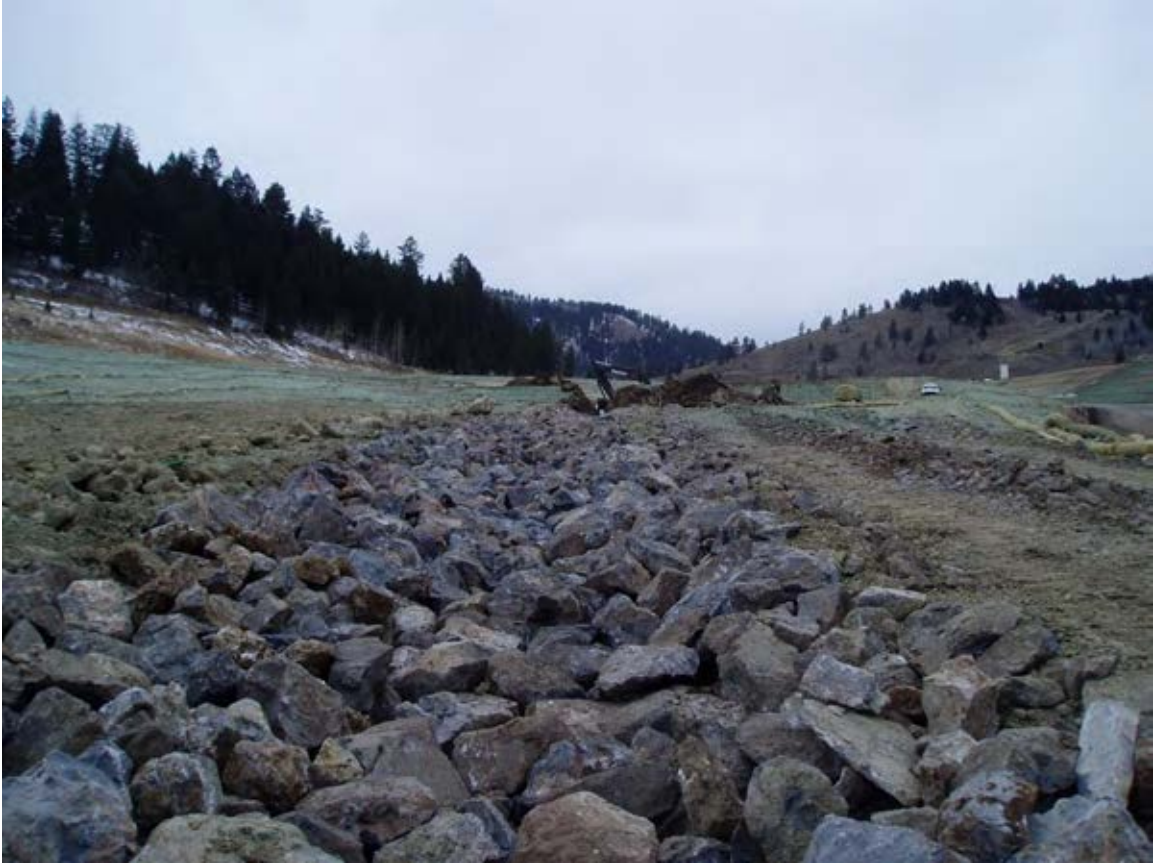
Photograph 6b: Looking north and upstream along West-Side Runoff Control Ditch downstream of West-Side South Sedimentation Basin at geofabric and riprap line channel.

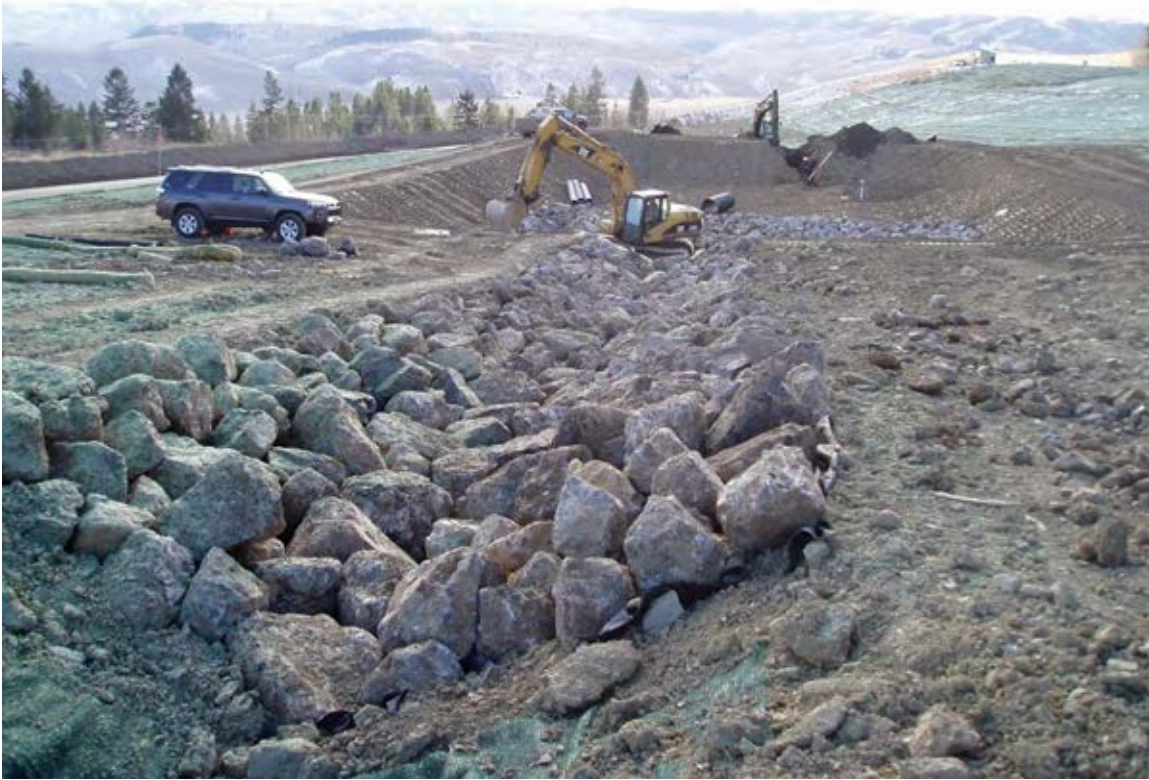
Photograph 7: Looking south at West-Side South Sedimentation Basin along geofabric and riprap lined inlet from West-Side Runoff Ditch. Excavator in basin is placing riprap at inlet chute outfall and excavator in background is setting low flow outlet pipe through south embankment.

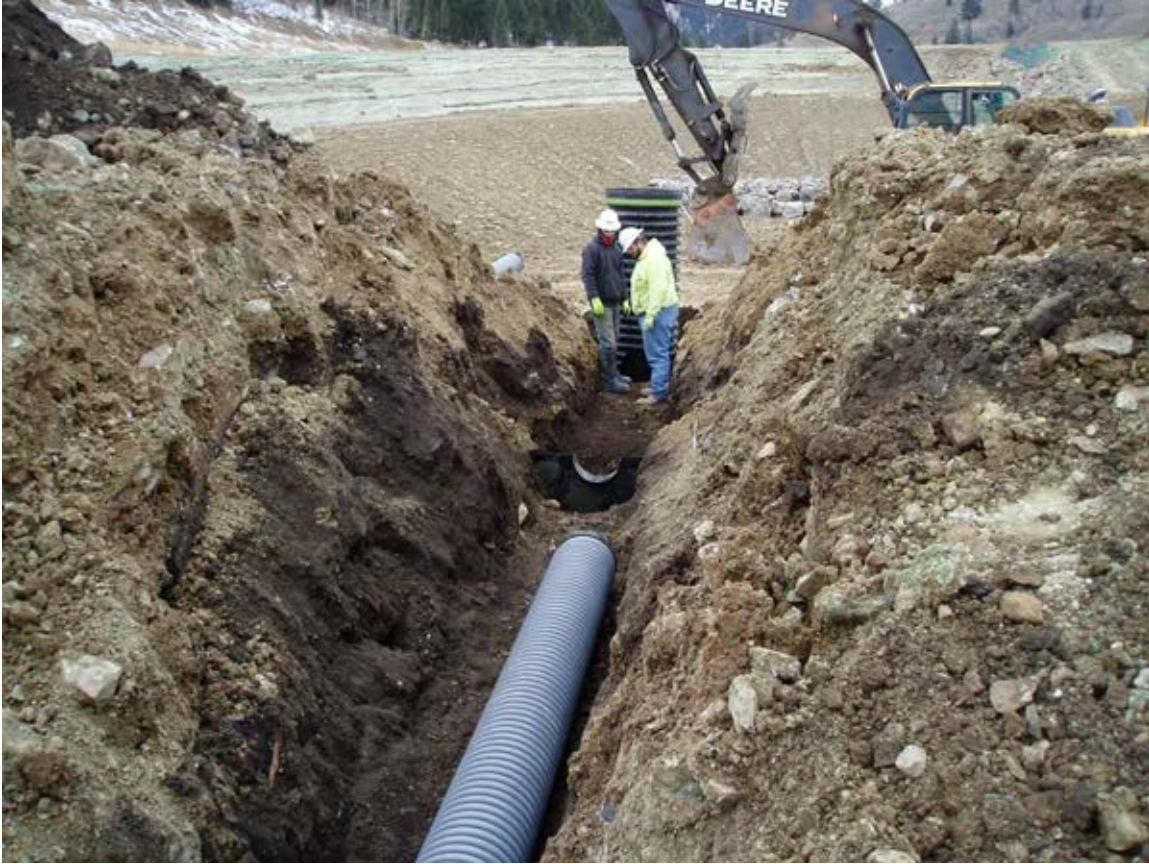
Photograph 8: Looking at excavation through south embankment of West-Side South Sedimentation Basin for 12-inch dia. low flow outlet pipe. Note pre-fab cutoff collar placed in trench floor upstream of embankment centerline.

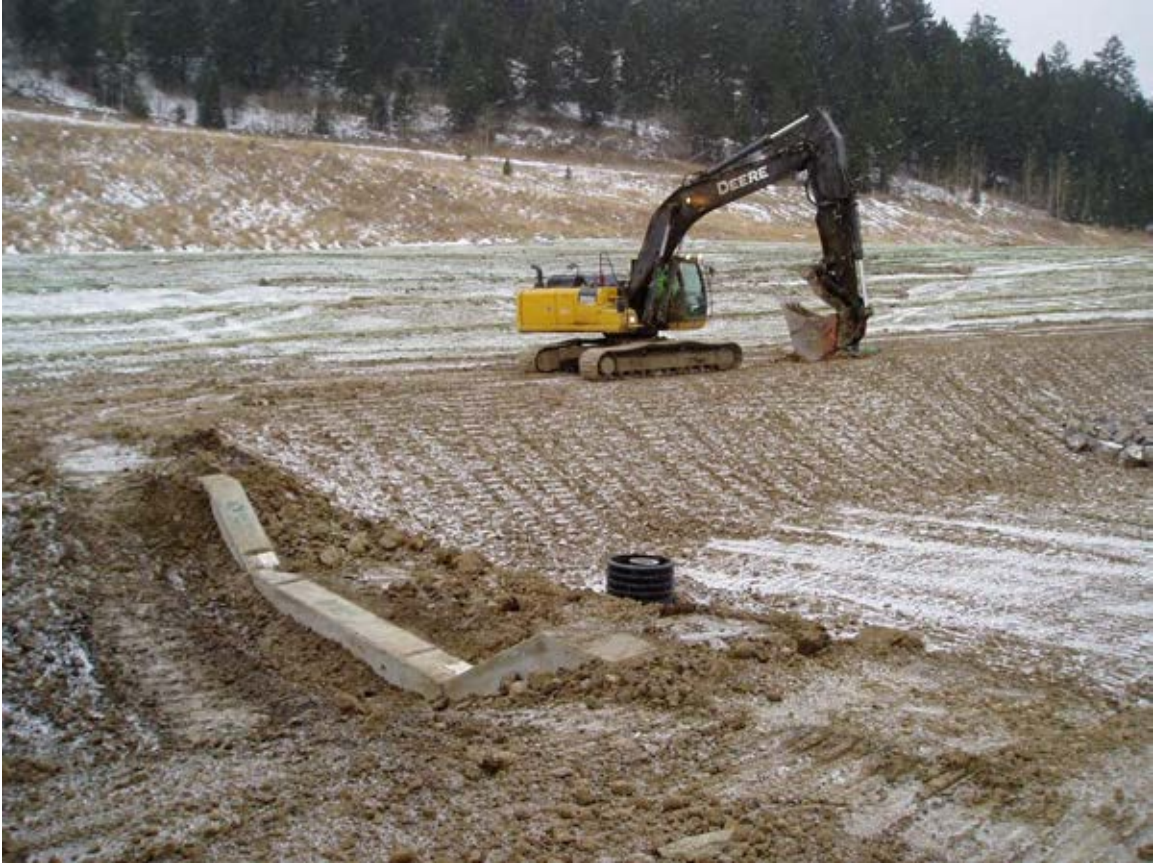
Photograph 9: Looking northwest across the West-Side South Sedimentation Basin at pre-cast concrete cutoff wall installed within basin spillway crest. Note low flow outlet riser in center of photograph.

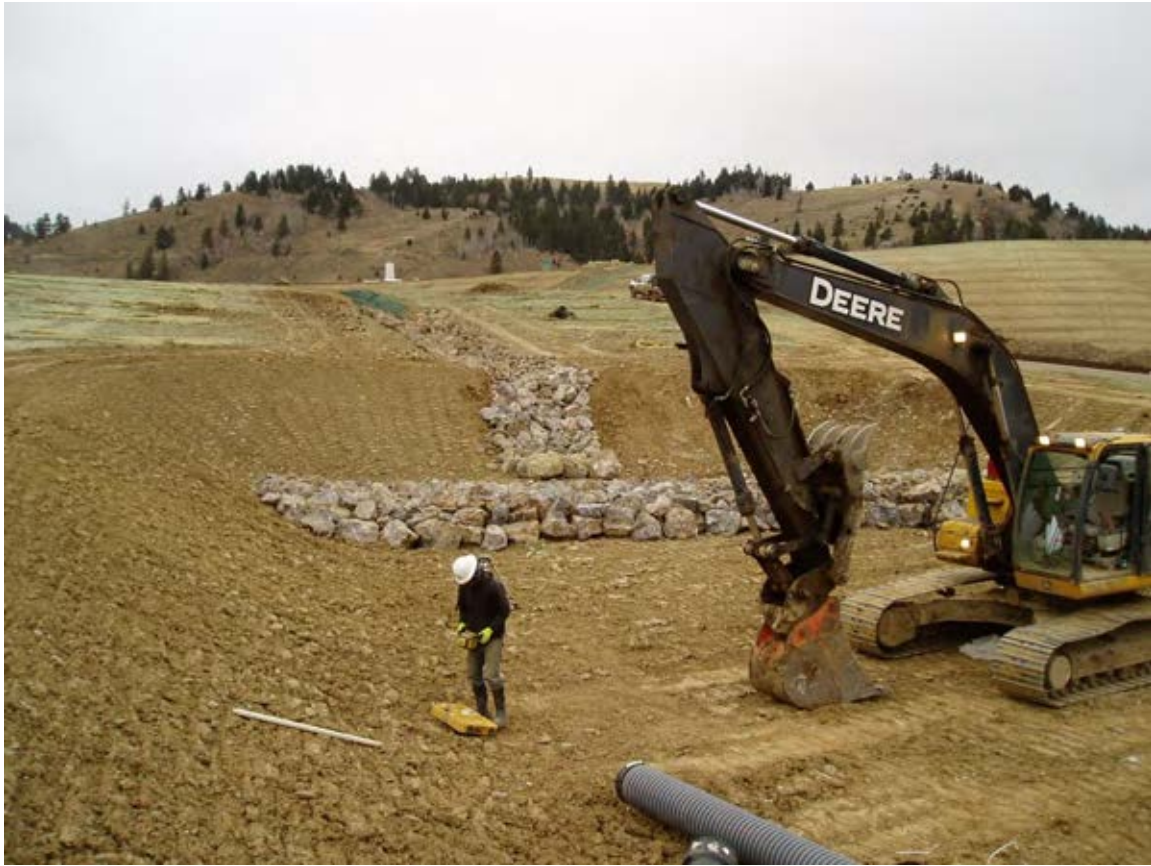
Photograph 10: Looking north across West-Side South Sedimentation Basin as grade check makes final measurement to confirm required elevations on top of Dinwoody liner.
